Intel[®] Celeron[®] Processor Specification Update

Release Date: October 2001

Order Number: 243748-038

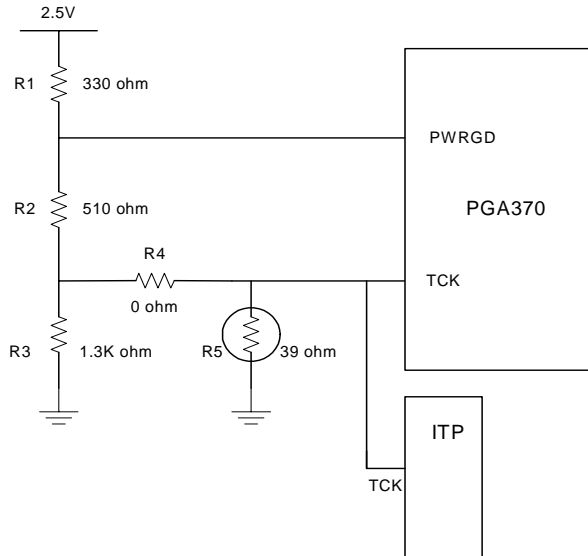
Celeron® on 0.13 micron Processor 256K Platforms Workaround

In addition, the example workaround circuits shown do not support production motherboard test methodologies that require the use of the processor JTAG/TAP port. Alternative workaround solutions must be found if such test capability is required.

For Production Boards:
Depopulate R5

To use ITP:
Install R5, Depopulate R4
